# **Inspection Report** Minerals Regulatory Program Report Date October 6, 2006

Mine Name: Santa Barbara Permit number: S0130006 **Operator Name:** Star Stone Quarries

Photographs
M0130006, Santa Barbara Mine, Start Stone Quarries
Inspection Dated: May 17, 2006; Report Dated: October 6, 2006

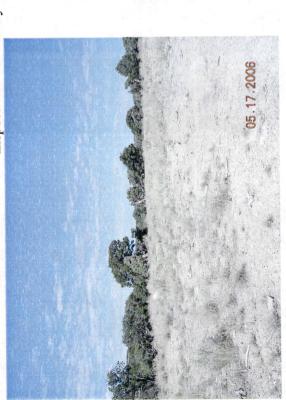
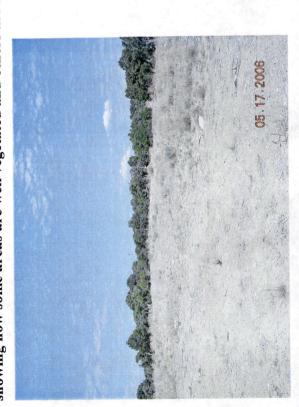
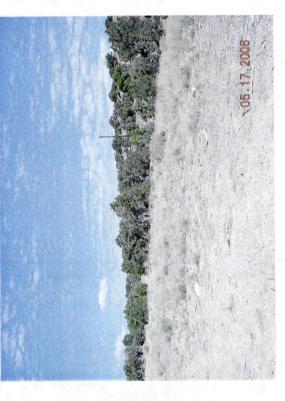
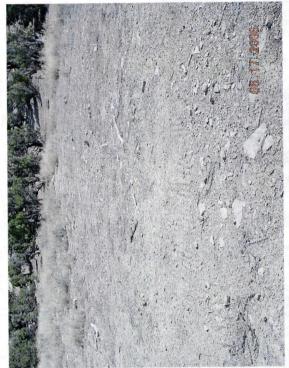
showing how some areas are well vegetated and others are not. Photo 1. These four photos are various views of the site
